Coastal Inlets Research Program

**Shinnecock Inlet, New York,
Site Investigation**

**Report 1
Morphology and Historical Behavior**

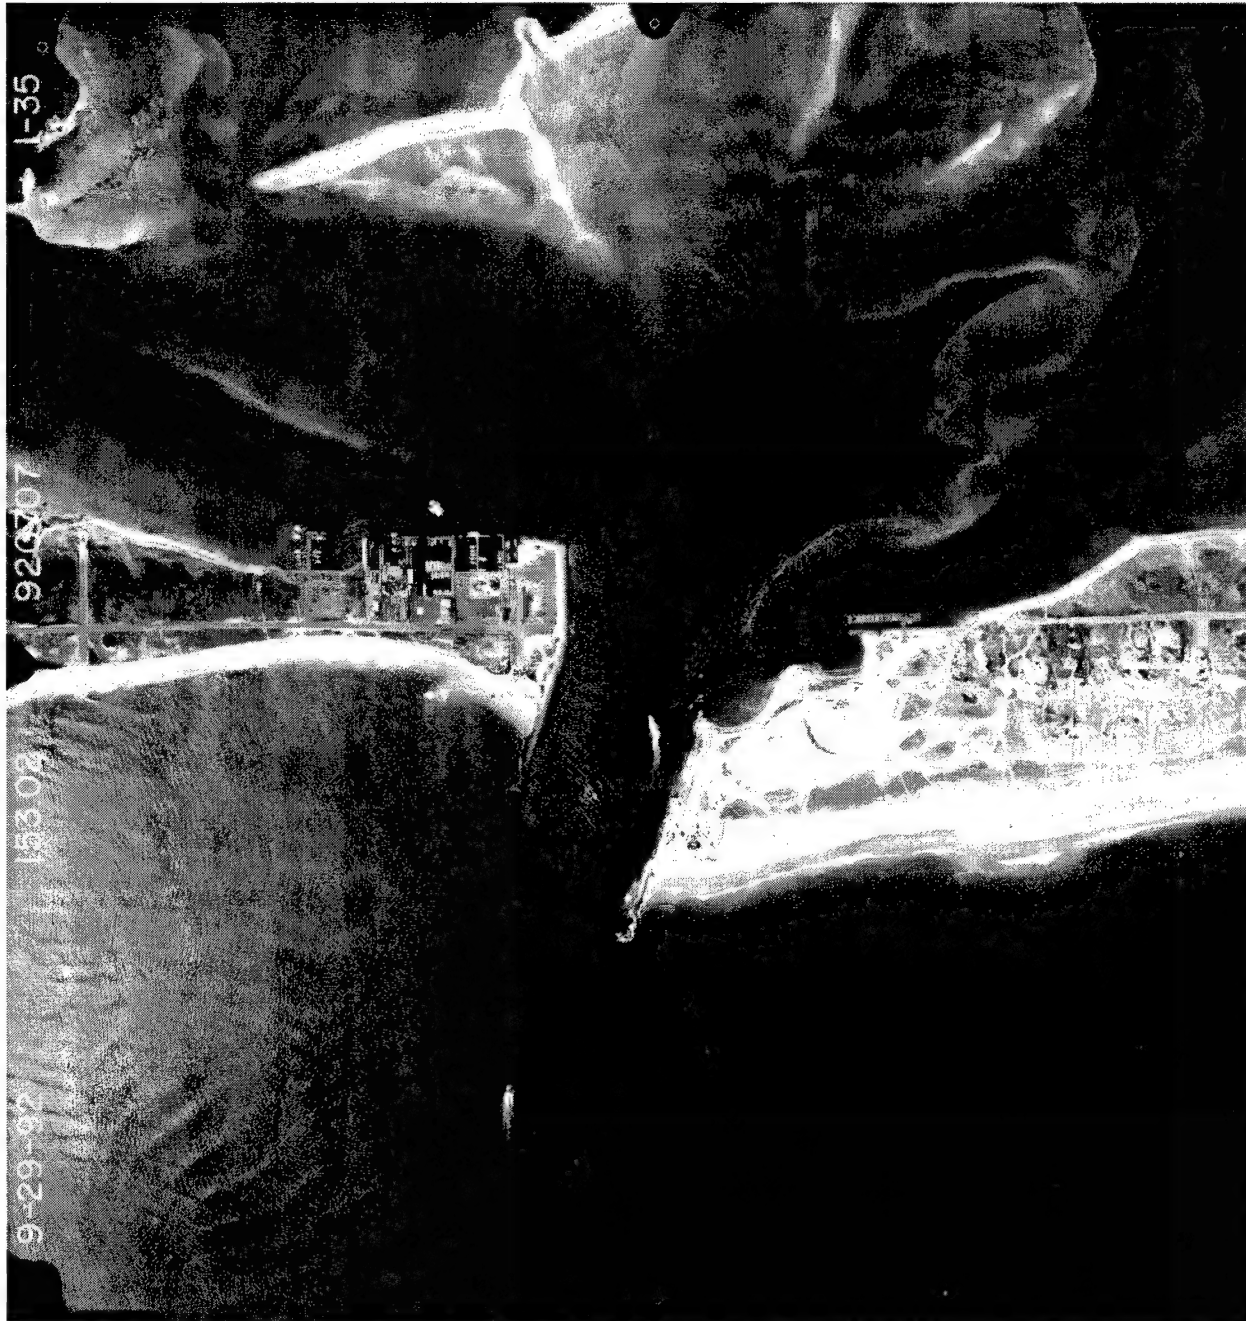
Figure A36. 29 September 1992 (East beach has advanced about 70 m compared with December 1991, and west beach has receded severely. More of the east revetment has deteriorated, accompanied with erosion of east shore. Jetty repair has begun, and a barge containing rock is moored in east channel in Shinnecock Bay. On the flood shoal, the right arm of the T-shaped sandbar has moved north)

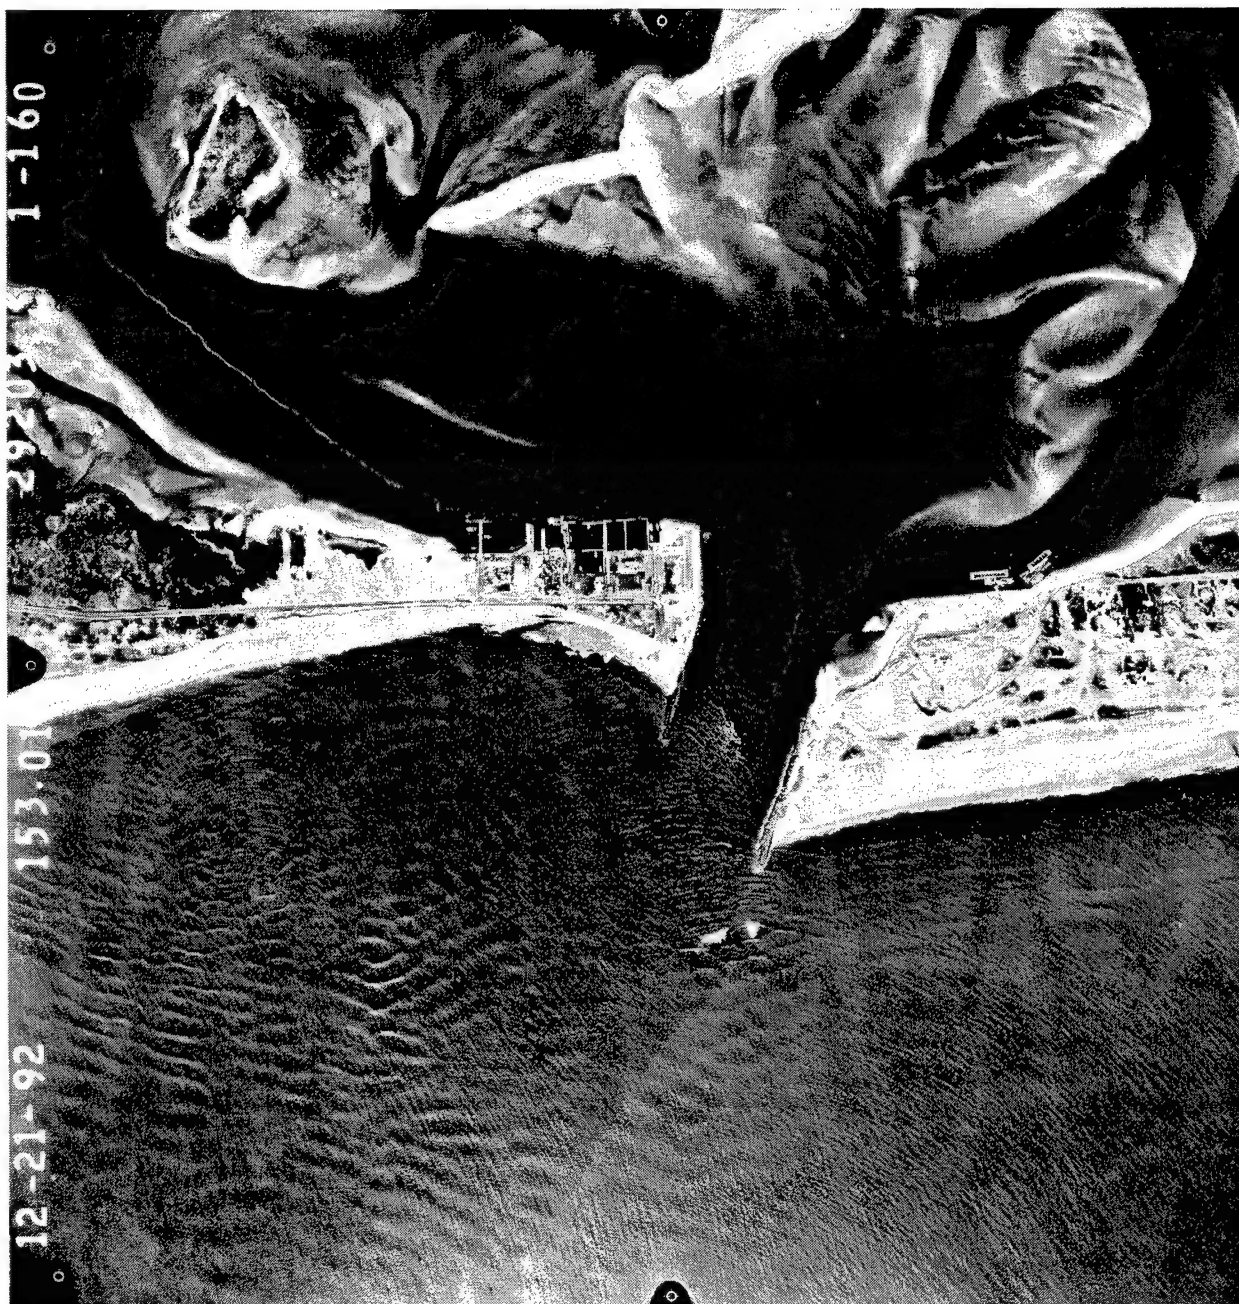
Figure A40. 21 December 1992 (Similar conditions as previous photographs taken 3 days earlier. Waves still appear to be concentrated along the east shore where part of the jetty has failed. T-shaped sandbar in flood shoal has been divided into two sections)

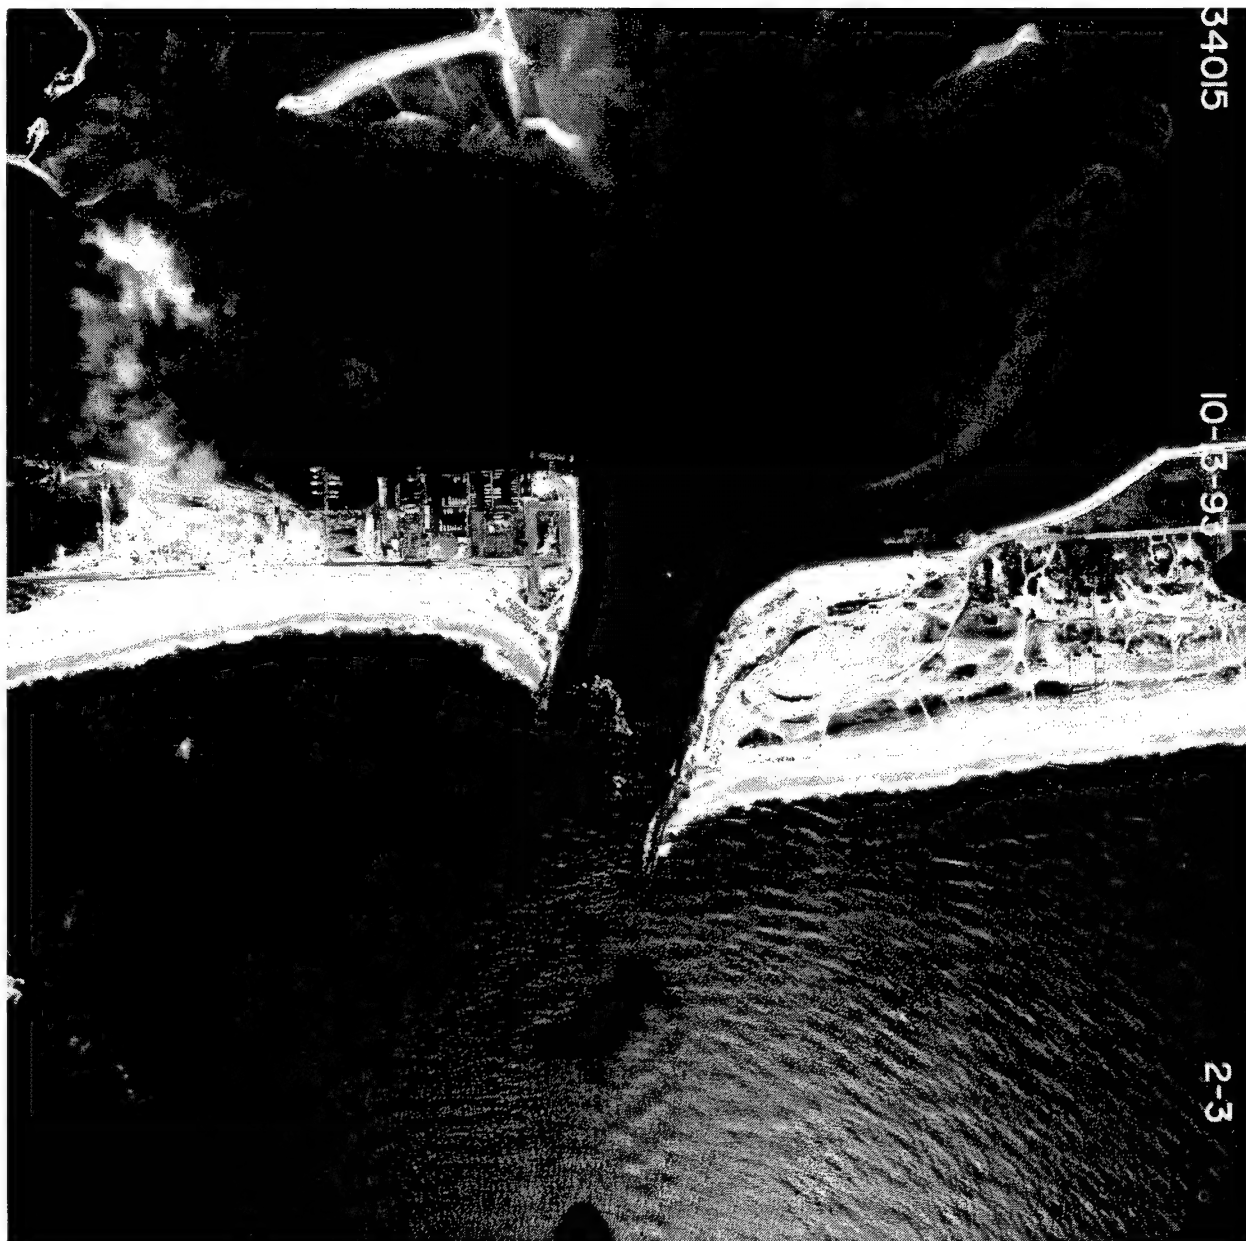
Figure A42. 13 October 1993 (Ocean shorelines have not changed since the previous photograph was taken in June. Repair of the east revetment is almost complete)

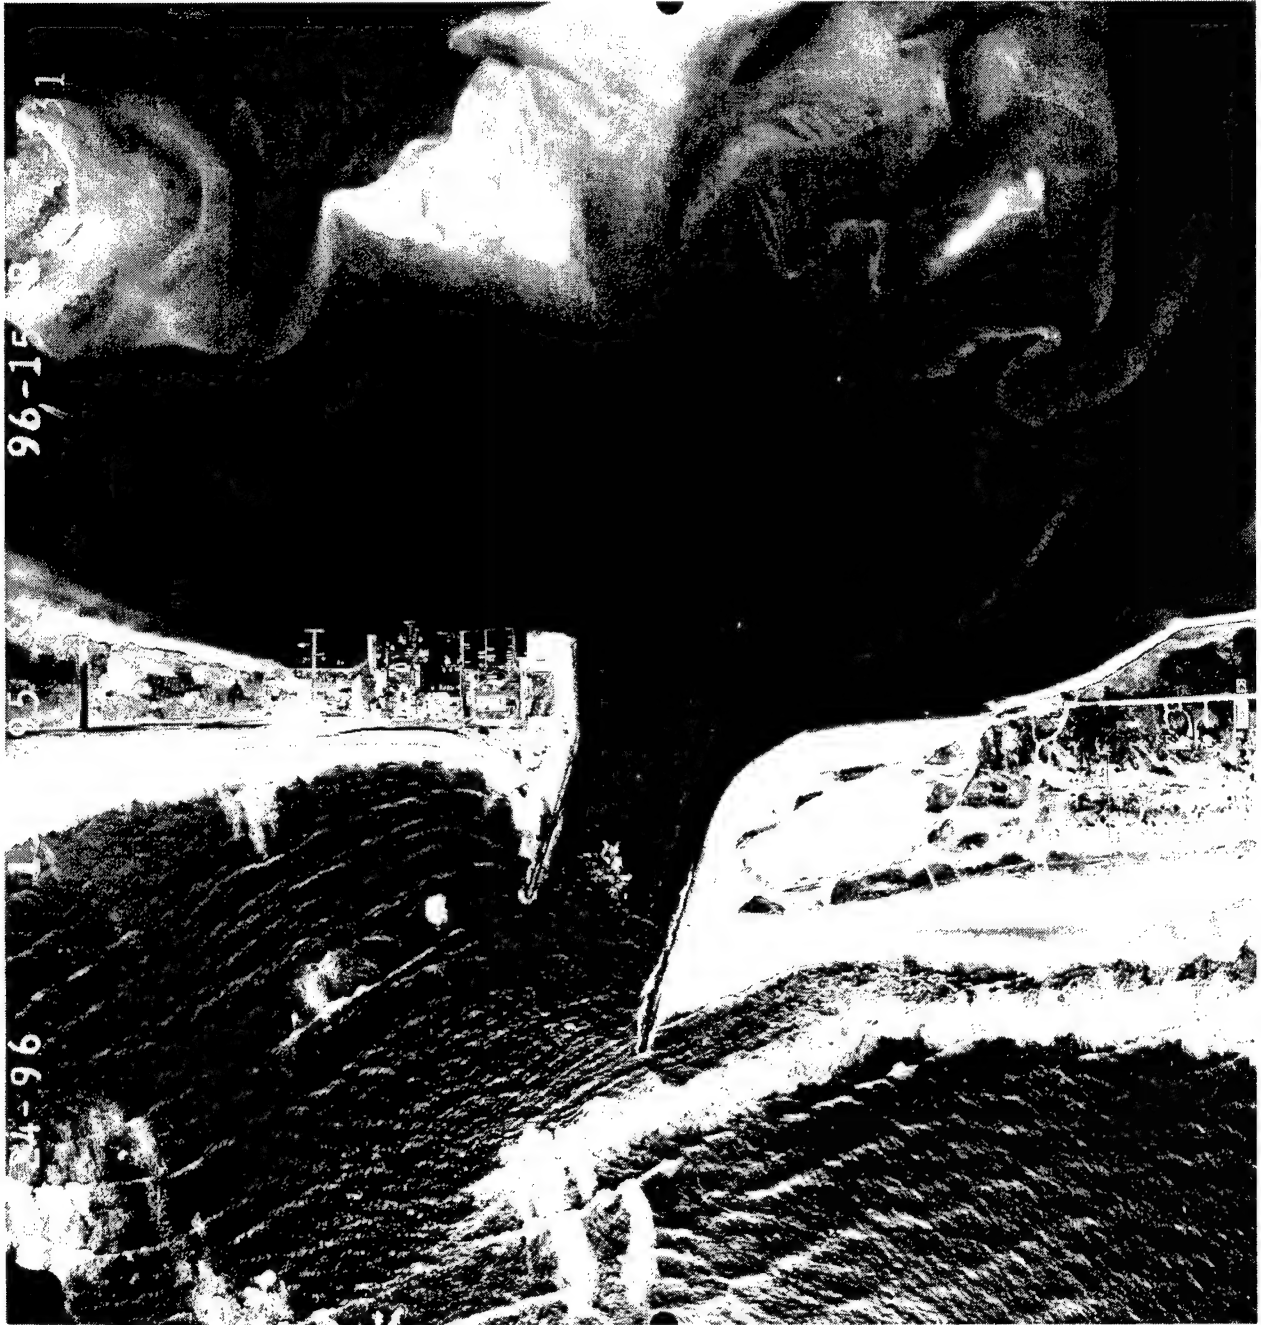
Figure A47. 24 October 1996 (No. 1 of two photographs for this date) (The west beach has continued to recede since April, while the east beach is largely unchanged, extending out to near the end of the east jetty. Breaking waves outline the east edge of the ebb shoal. Shoal merges into shore-parallel sandbars about 200 m east of the east jetty)

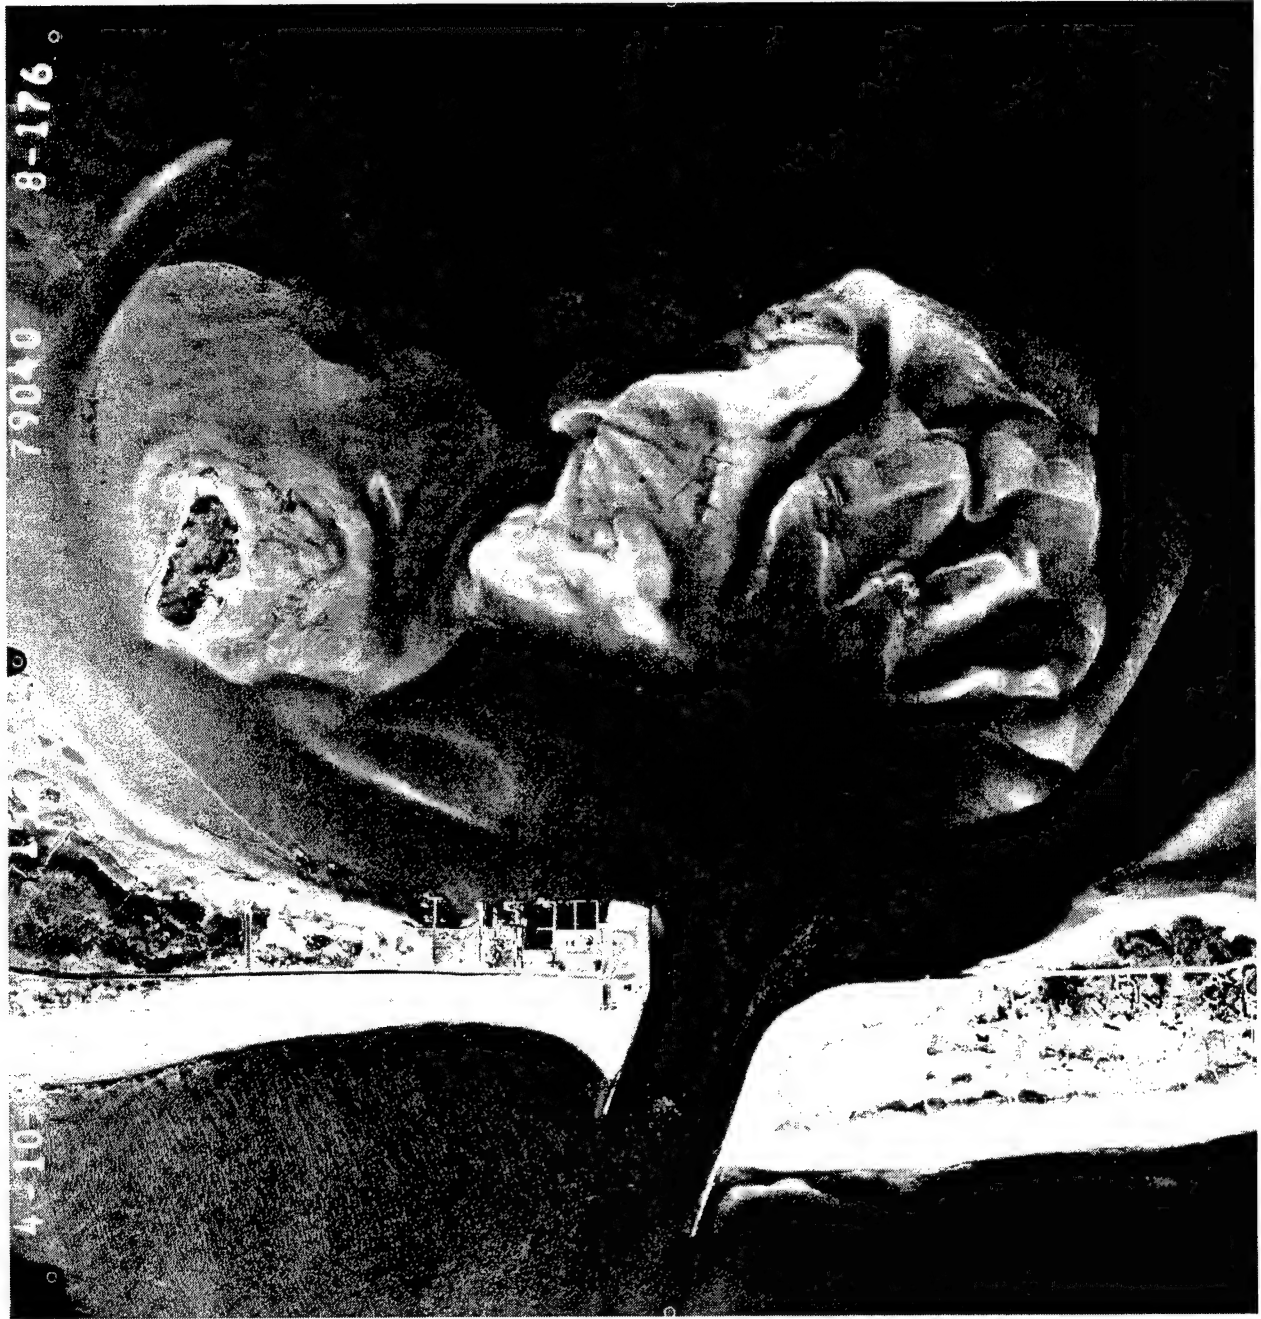
Figure A49. 10 April 1997 (East beach has receded about 100 m from tip of west jetty. West beach was repaired with sand dredged from channel in February and March (see Table D1). Active portion of flood shoal is now symmetrically positioned in line with axis of inlet. This is east of its 1970s position)

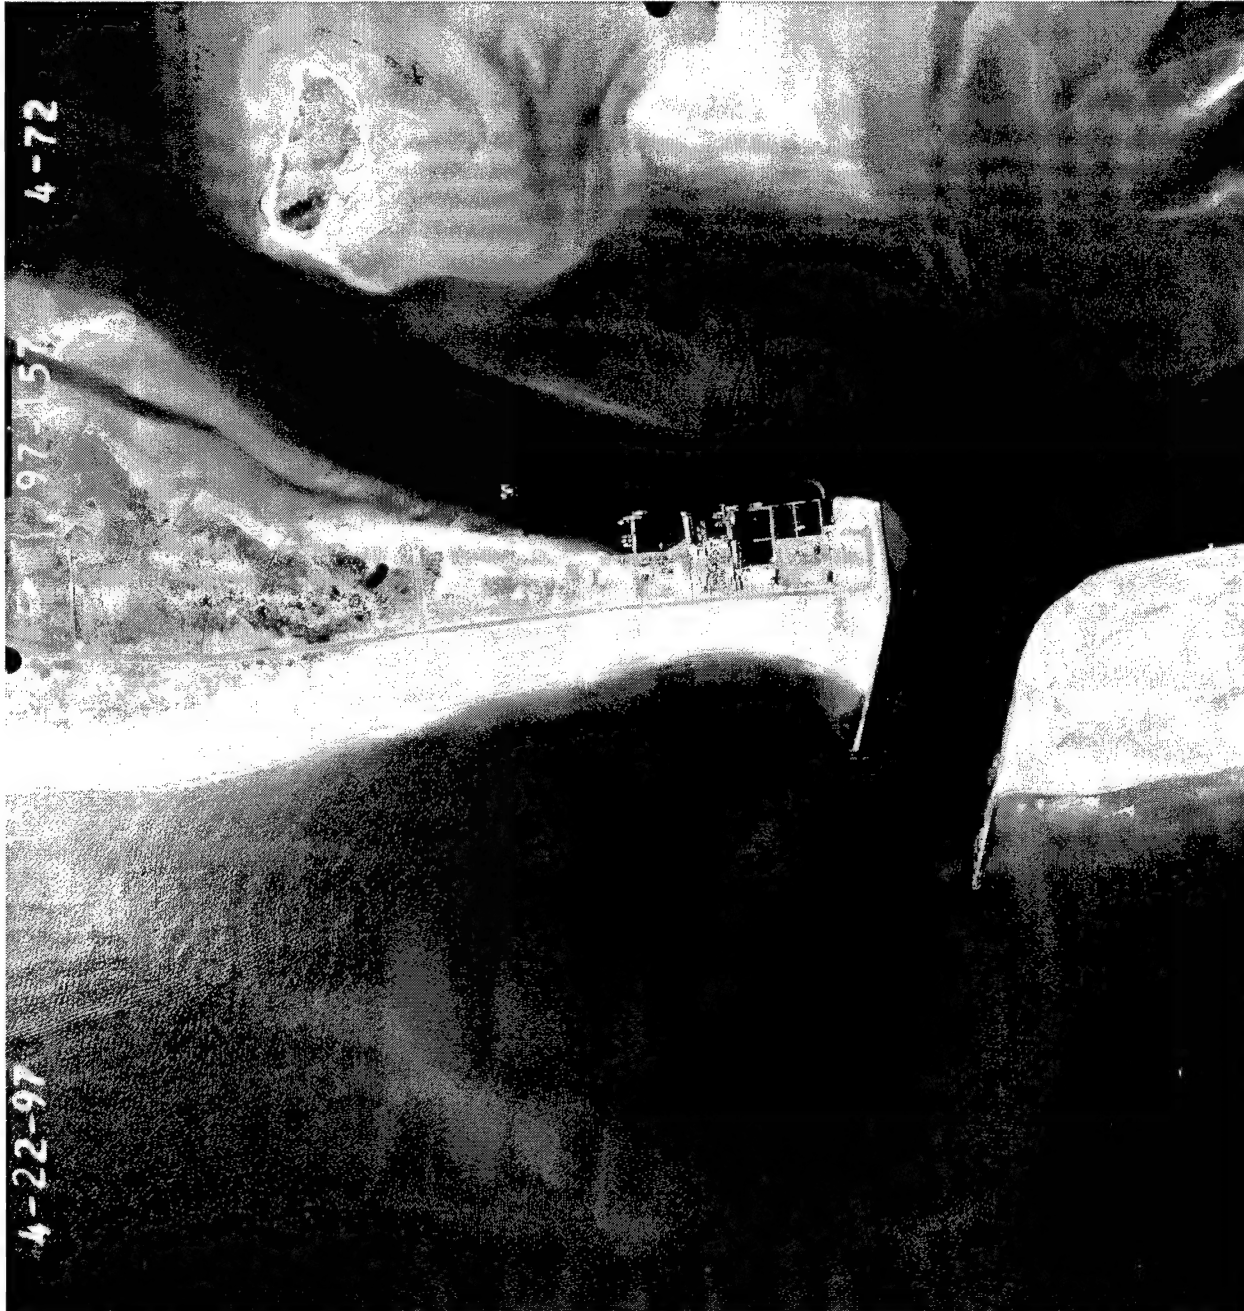
Figure A50. 22 April 1997 (Edge of ebb shoal is clearly visible in this image, taken on a day with almost no waves. Water depth at the bar is about 3 m (10 ft). Dark water off the mouth of the inlet is the dredged deposition basin. A ridge of sand that projects seaward from the west jetty and a deep hole to its west were measured by bathymetric surveys (see Appendix B))
